September 1, 2004

Final Report

SERDP Pollution Prevention Project 1137

Non-Destructive Testing of Corrosion Under Coatings

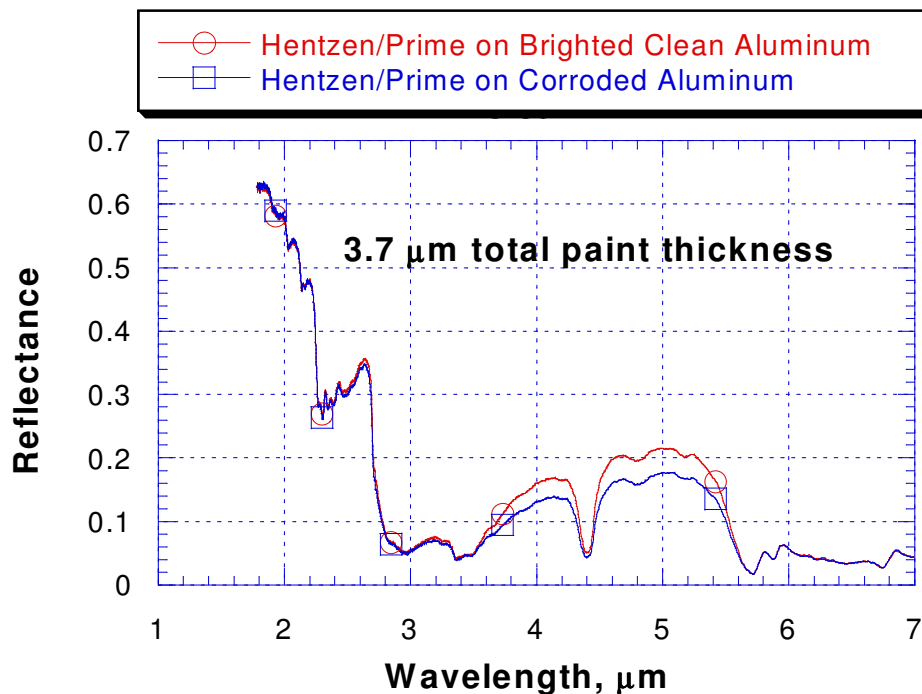
Figure 7 Reflectance of Hentzen paint system on a partially corroded aluminum coupon. Significant reflectance difference seen in the 3.6 to 5.4 μm range between corroded and uncorroded areas

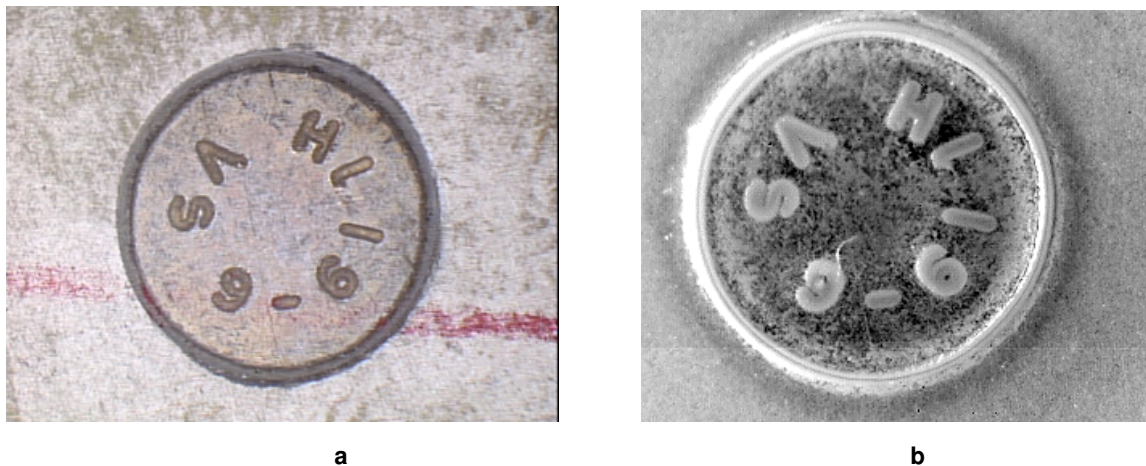
Figure 59 shows a visual image on an unpainted fastener head next to an IR image of the same fastener covered with 3 mil of primer and topcoat. The fastener markings can be clearly seen through the coating.

Figure 59 A visible image (a) of an unpainted fastener head, an IR image (b) of the same fastener covered with 3 mils of primer and topcoat.

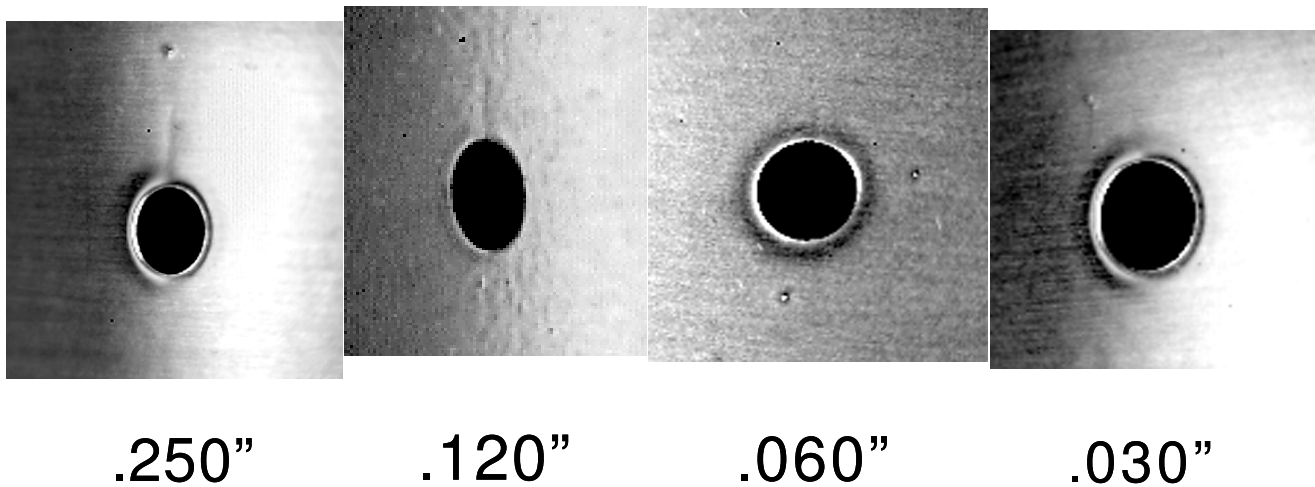
Figure 63 Successively smaller length fatigue cracks imaged under 3.5 mil primer and topcoat using a 25 mm IR lens.

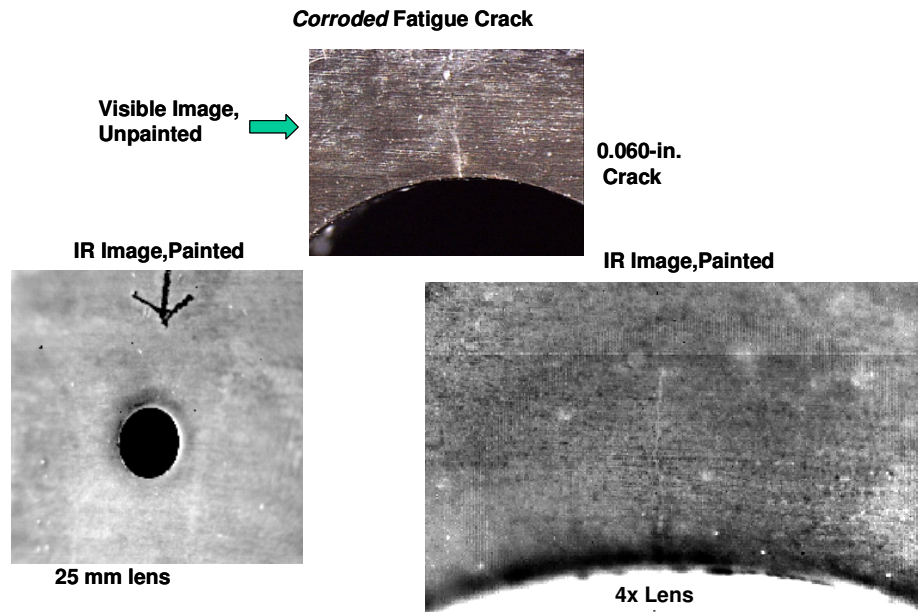
Figure 82 Corroded crack (photo No. 1) produced in the lab by placing the 2024-T3 bare, aluminum specimen in salt water for a number of days. This specimen although not totally realistic maybe more indicative of a more open crack. Photos No. 2 and No. 3 are of painted bare panels under IR illumination.

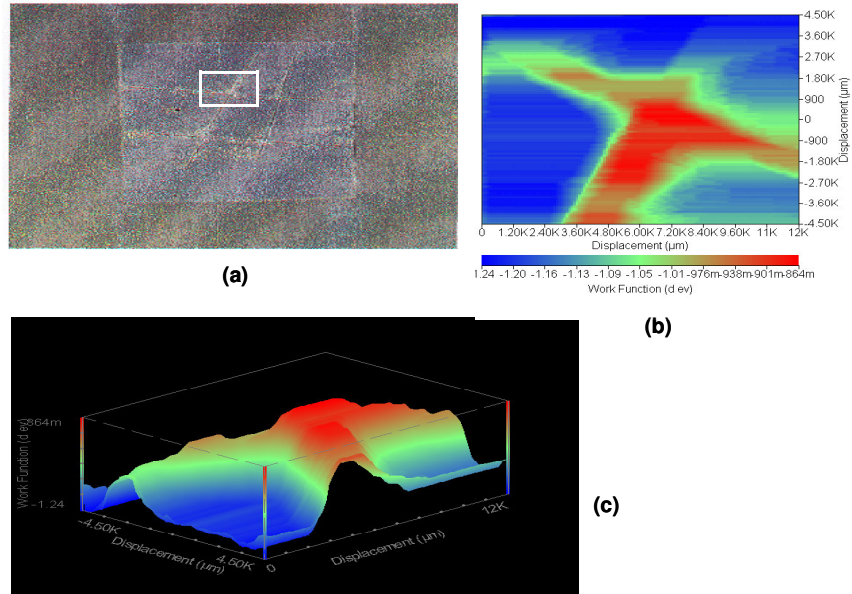
Figure 126 Volta potential measurements over corroded and painted AA2024; (a) photograph of the scanned area before painting; (b) 2D image of the Volta scan of the area; (c) 3D image of the Volta scan of the area showing the location of corroded regions.

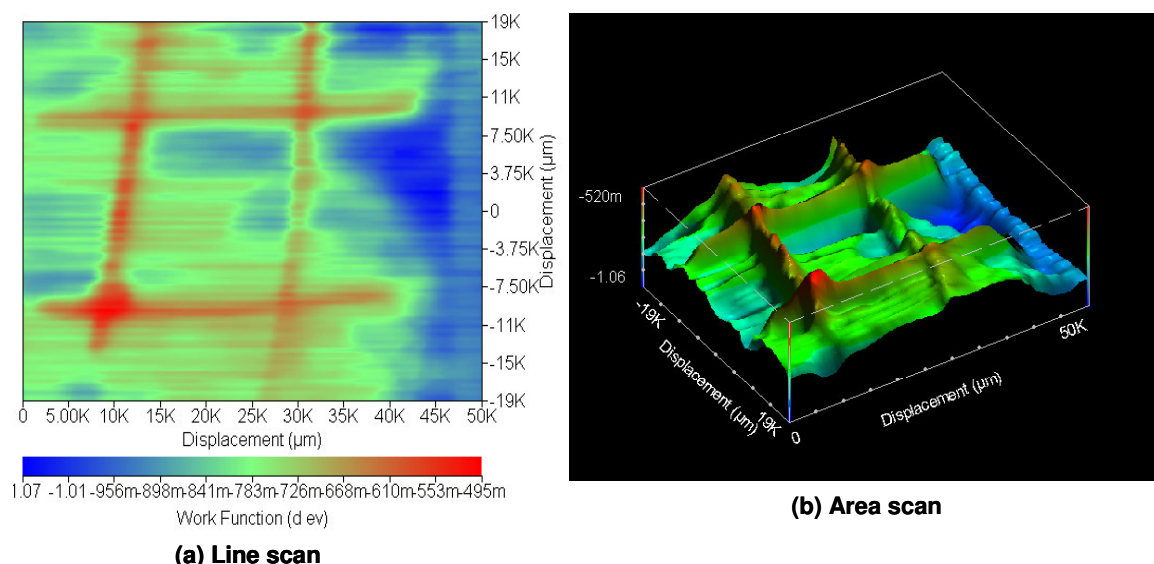
Figure 131 shows SKP measurements of the corroded clad chromate conversion coated AA2024 covered with several layers of paint. The sample was masked leaving a square section exposed. The unmasked area was scribed, and the sample was then exposed to salt fog for an extended period of time. After corrosion the masking was removed and the entire sample was coated with PRF 23377 primer and a Hentzen gloss white topcoat so that

Figure 131 SKP Volta potential measurements of corroded clad Al alloy AA2024 covered with several layers of paint. The overall thickness of the paint is 5.6 mil.

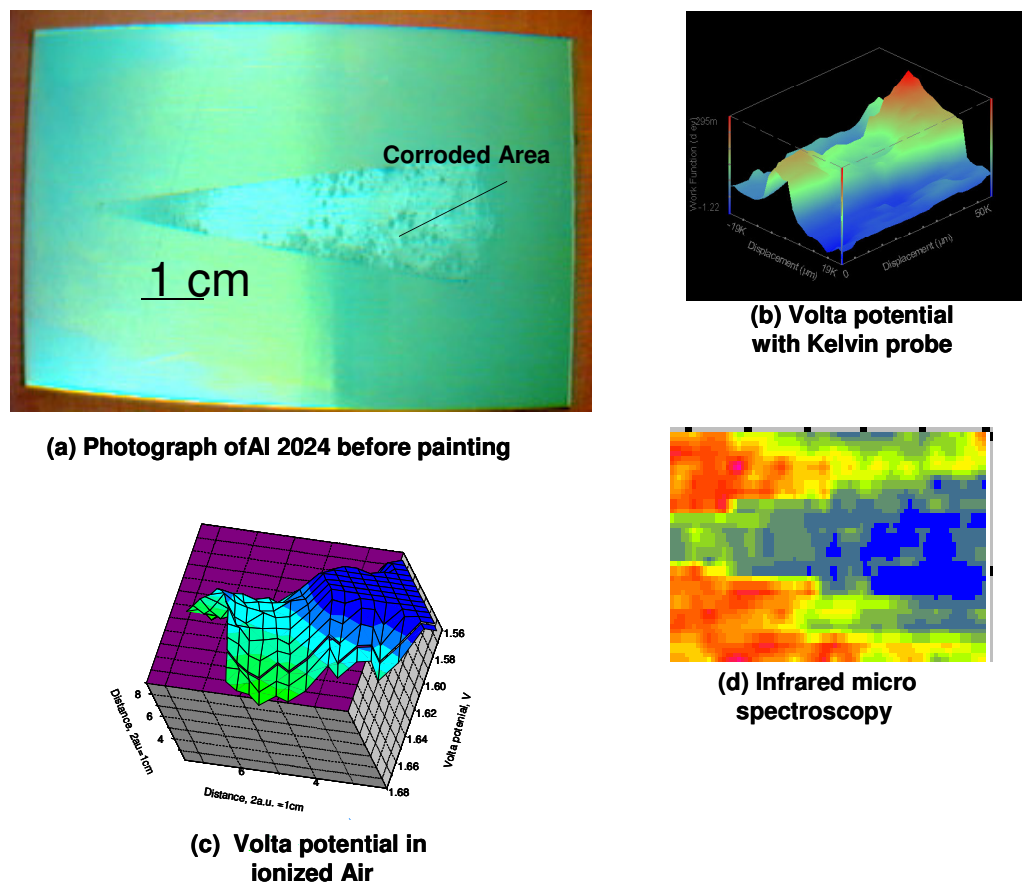
The SKP results are shown in Figure 132b. The map of the scanned surface obtained by Volta potential measurements in ionized air is shown in Figure 132c. The 3D map of Volta potential shows the difference between the corroded and non-corroded areas. The last image in Figure 4d represents the results obtained by infrared microscopy. The intensities of the peaks at 1042 and 2086 cm^{-1} were used to generate the 2D plot. It exhibits the same locations of corrosion, as the two Volta potential techniques. All three techniques can therefore be used to detect of corrosion under paint.

Fig. 132 Detection of corrosion under 3.6 mil paint layer using three different scanning techniques.

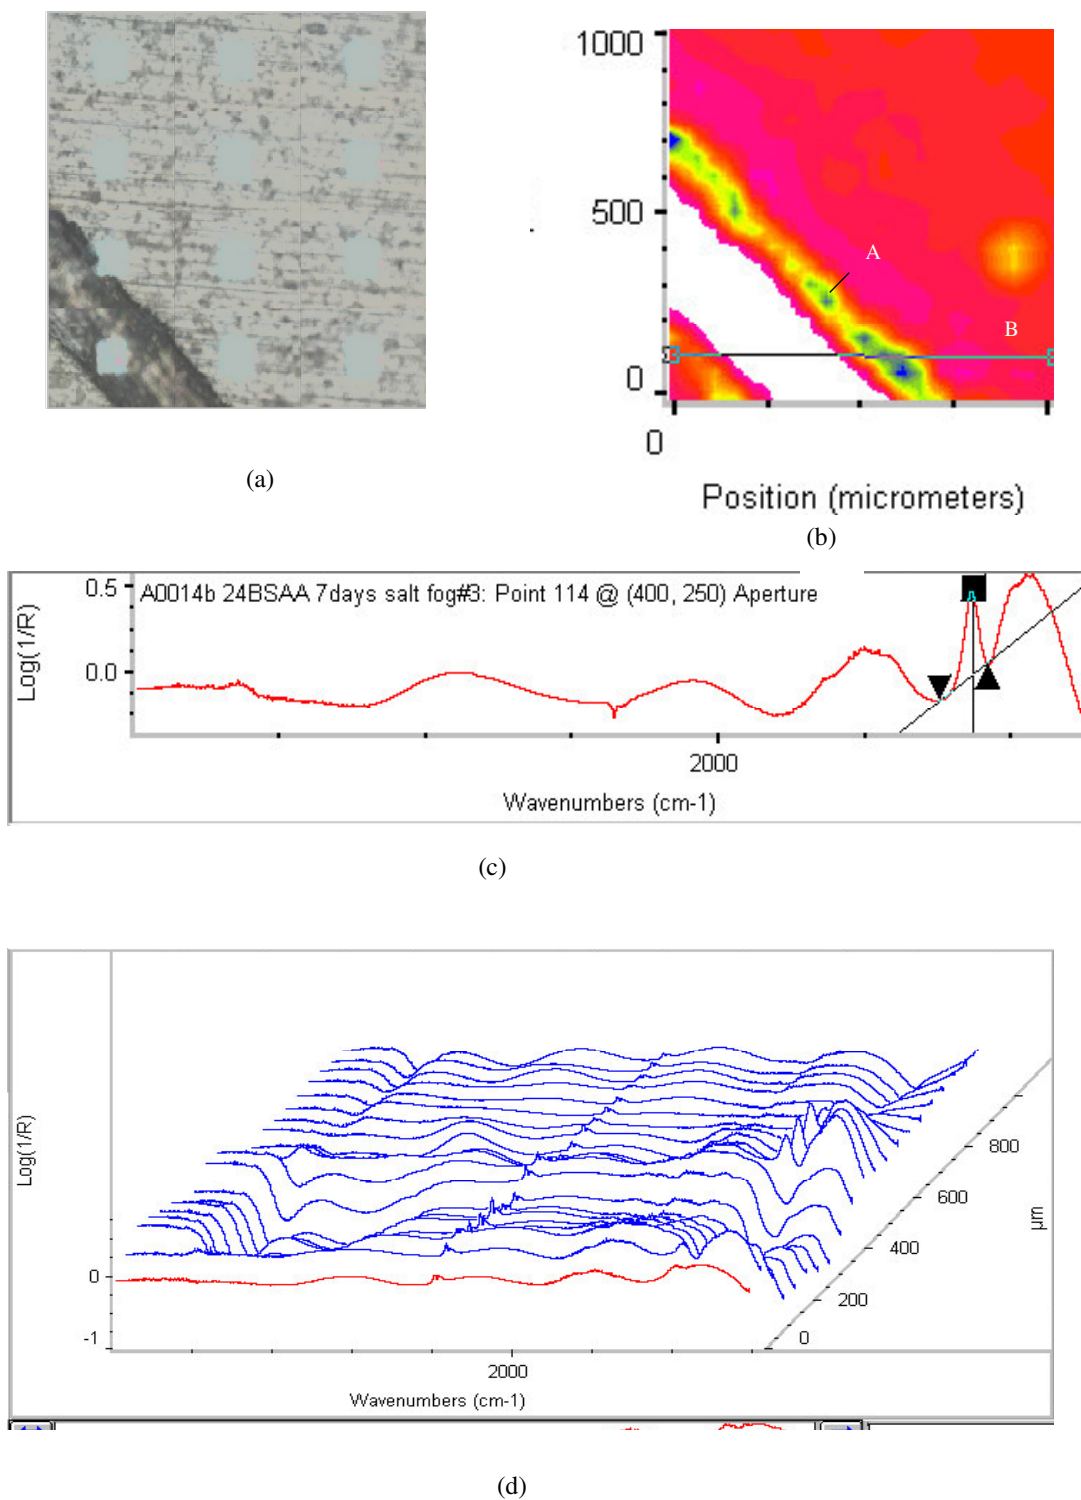
Figure 133 IMS of corroded sulfuric acid anodized AA 2024: (a) photograph of the scanned area; (b) map for the variation of the peak height at 1149cm⁻¹; (c) spectrum in point A shown in (b); (d) spectra along the line B shown in (b).

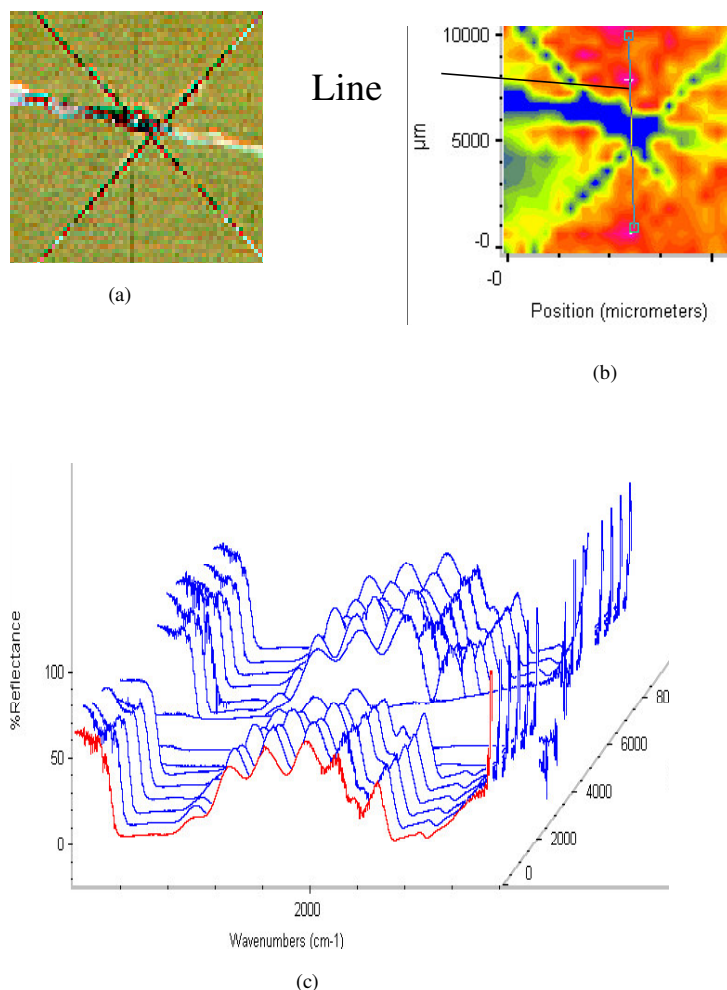
Figure 135 IMS of AA 7075 anodized in sulfuric acid after crevice corrosion under masking. (a) Photograph of the scanned area; (b) variations of the reflectance intensities for the region 1560 – 1670 cm⁻¹; (c) reflectance IR spectra along the line shown in (b).

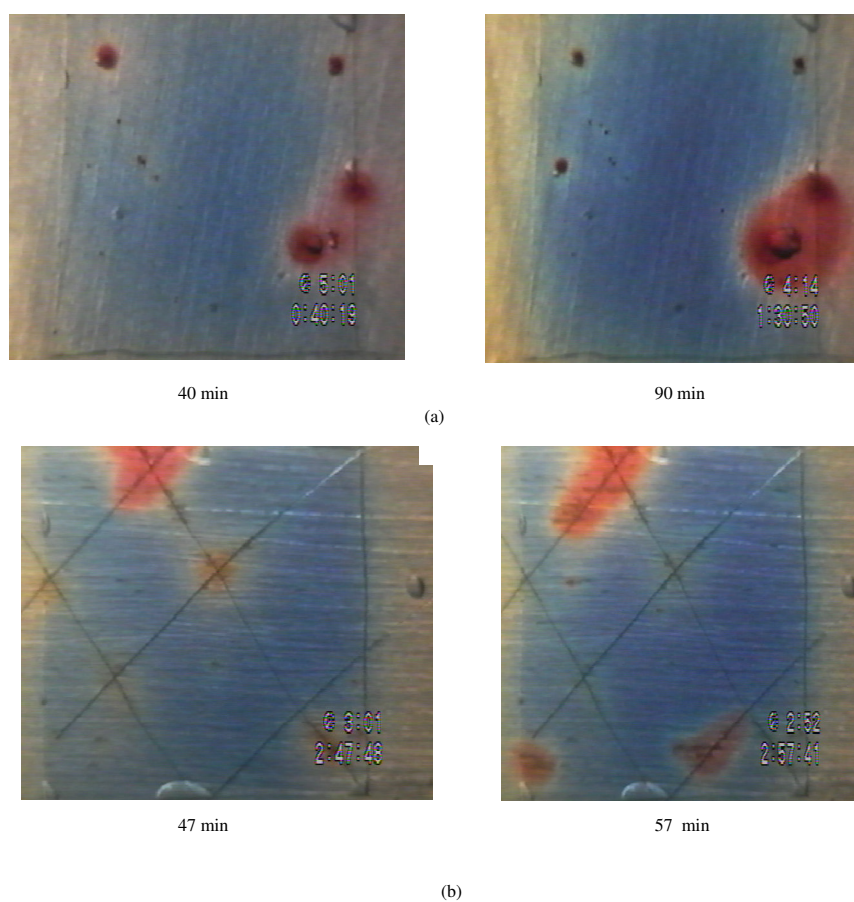
Figure 136 Video images of the corrosion in 1M NaCl Agar gel: (a) Al alloy AA2024; (b) Al alloy AA7075.

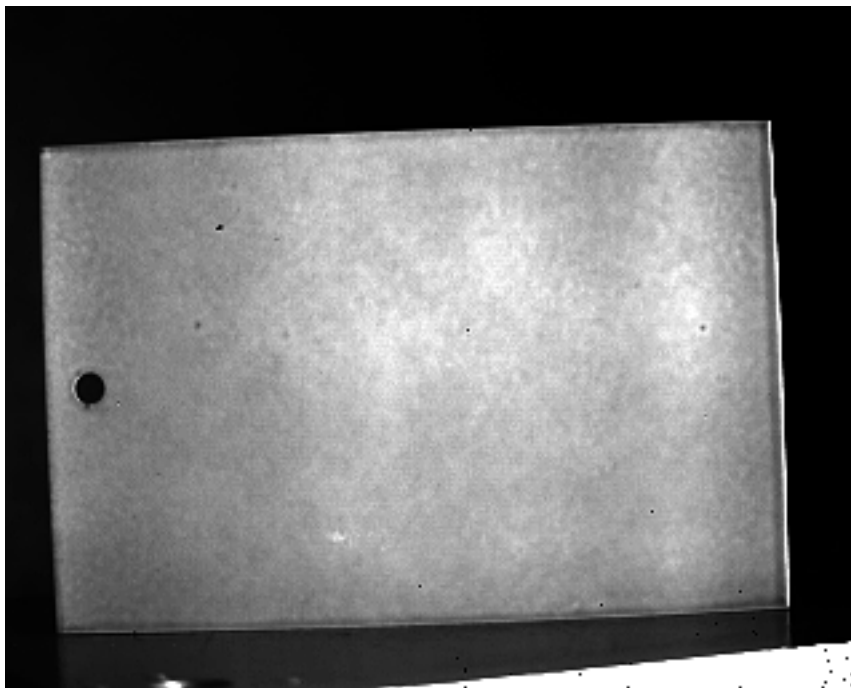
21 j5

IR Photograph does not indicate the presence of corrosion.

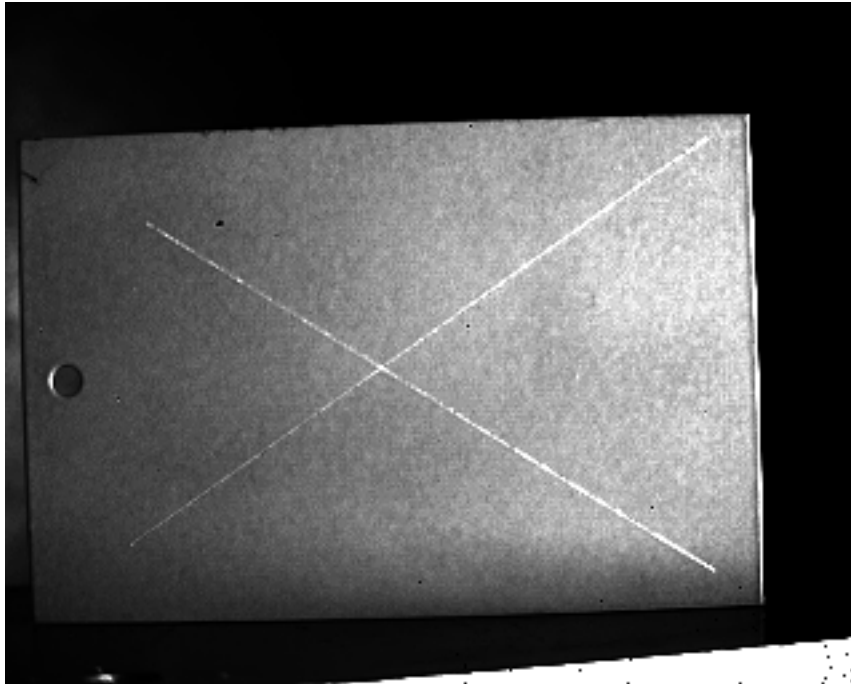
31 C4

IR Photograph indicates minor corrosion in scribed zone.

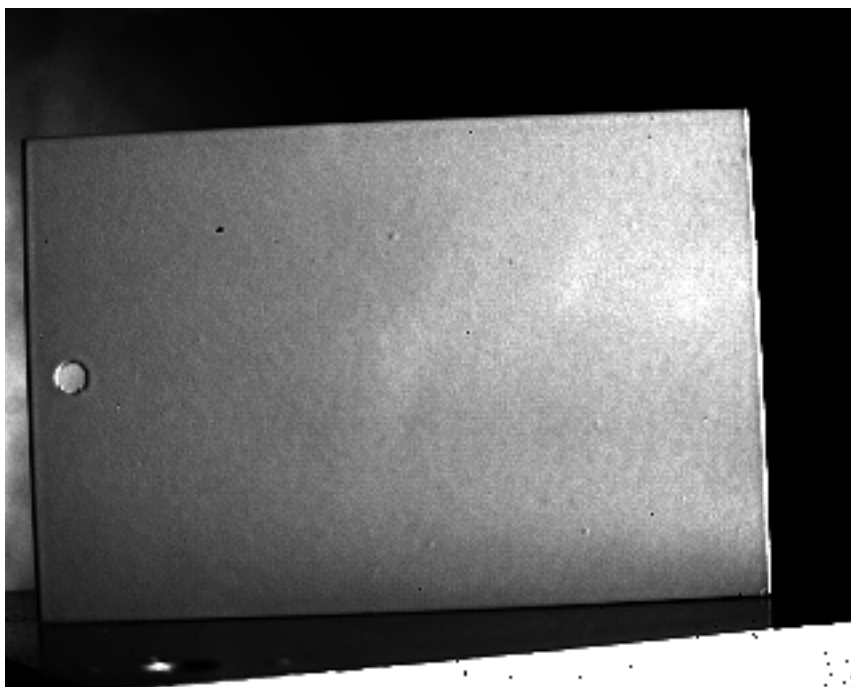
31 j1
IR Photograph
No corrosion observed

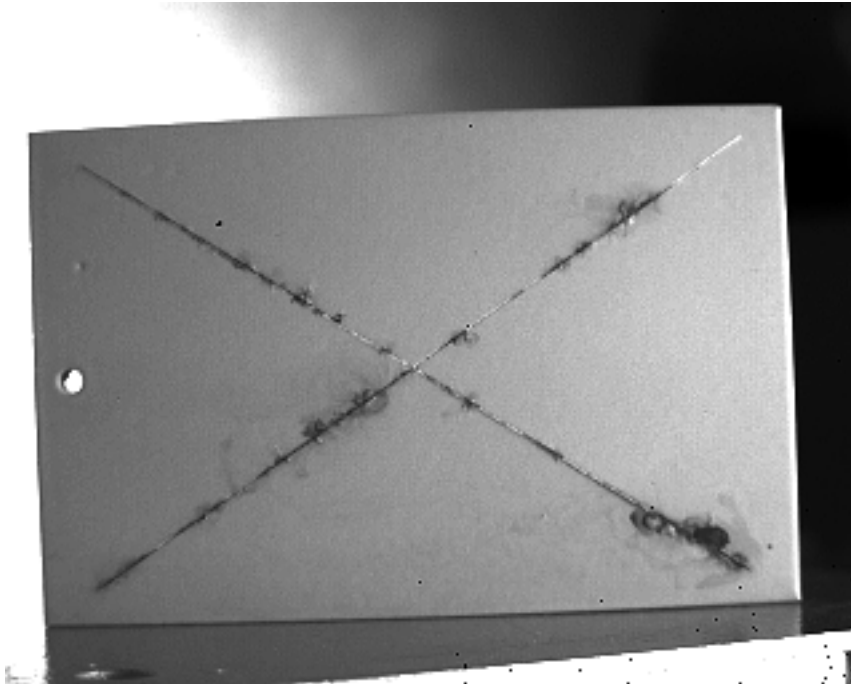
47 C4

Extensive corrosion in scribed area with corrosion under coatings extending from scribed area. Additionally there are indications of corrosion under the coating in areas that are not yet peeling.

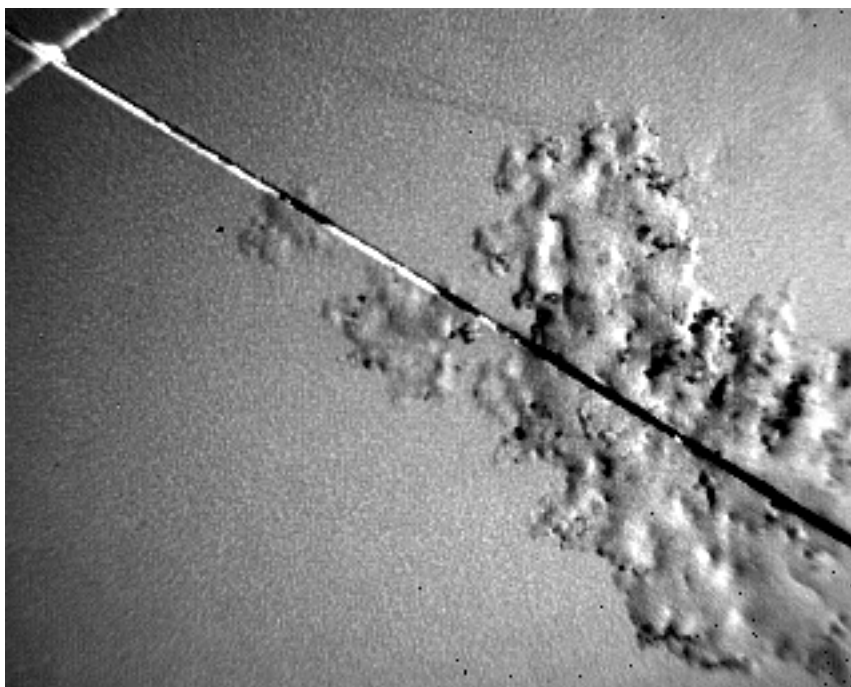
47 e1 Close 3
IR Photograph
Comments same as close 2 above.

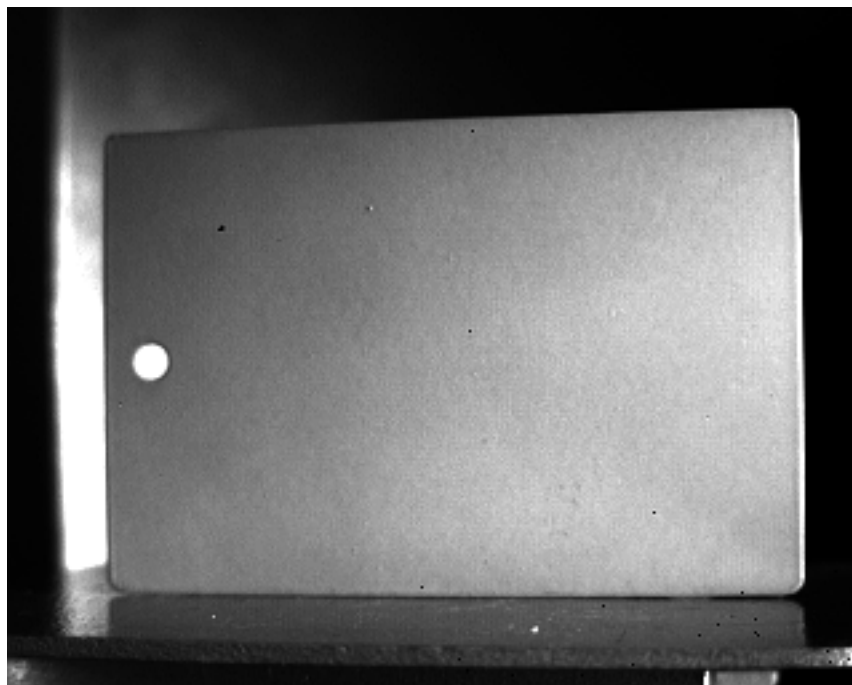
7i 1
IR Photograph
Indicates no corrosion present.

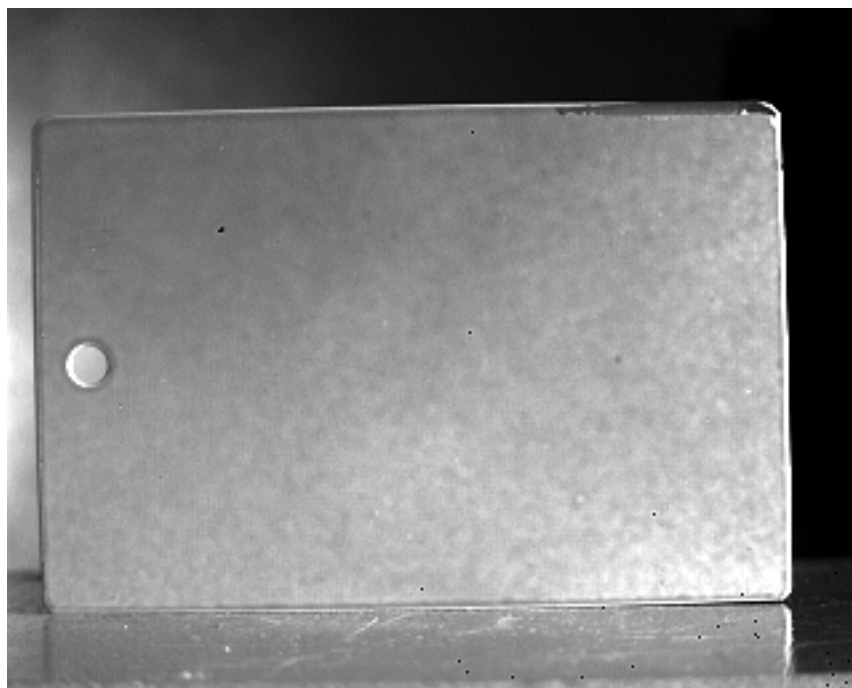
7i b
IR Photograph
Indicate potential for corrosion under coating or possible surface roughness.

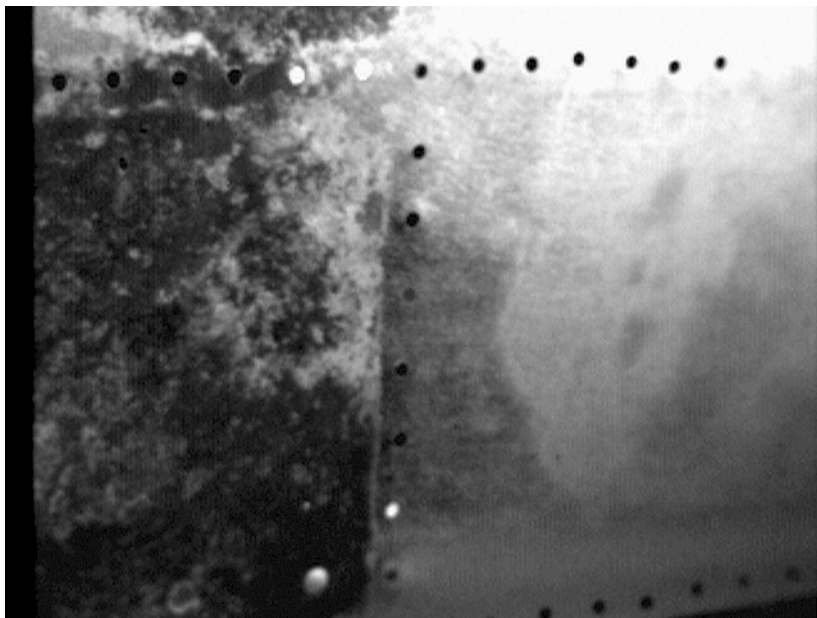
Visible and IR images of belly skin. One side is corroded, the other side has primer on surface.

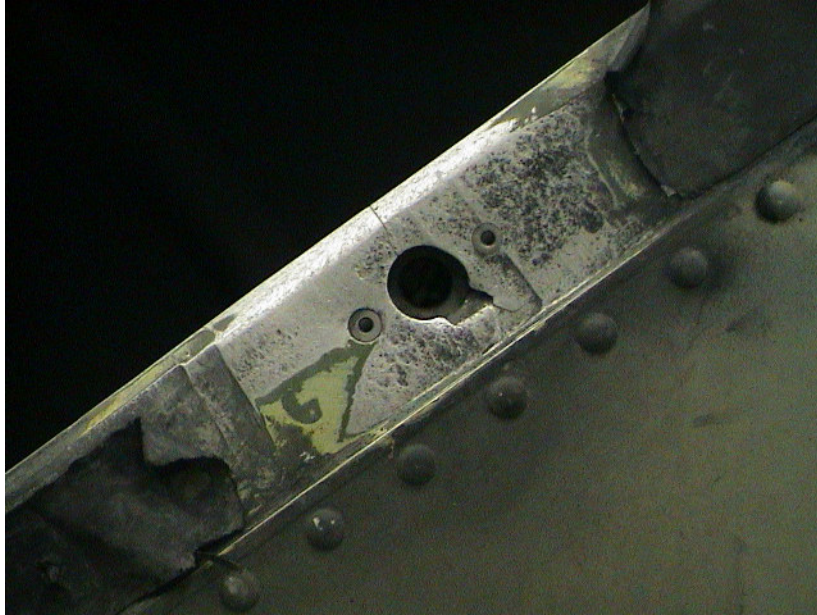
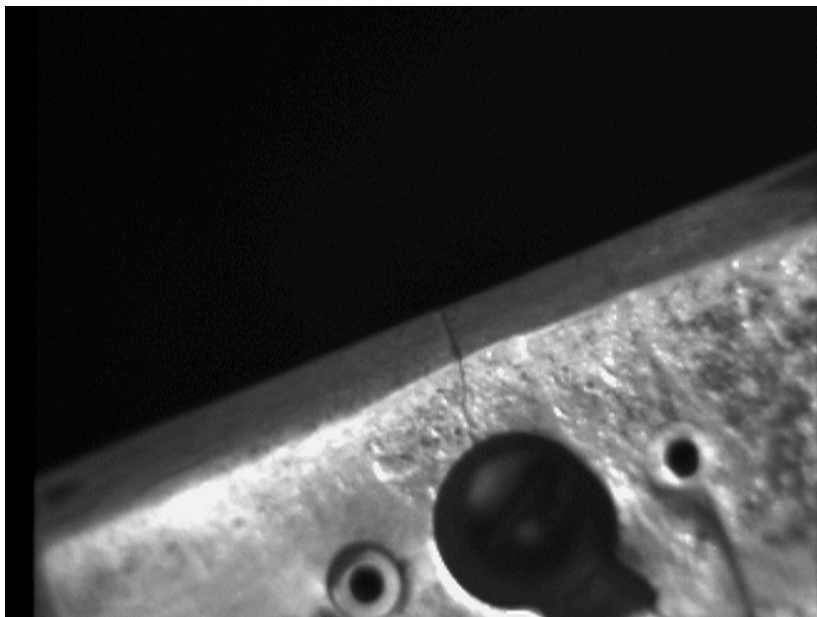
Visible and IR images of crack.
